Beneficial Home Inspections

Your Home Inspection Report

PROPERTY INSPECTION REPORT

Concerning: 2222 Sample Street Sample, TX
(Address or Other Identification of Inspected Property)

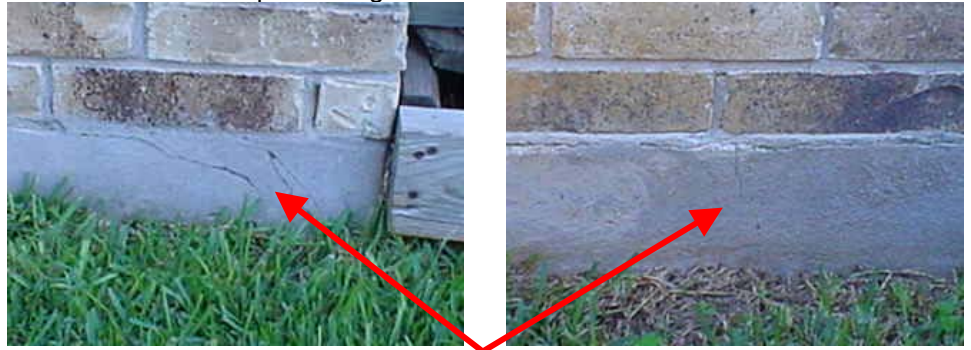
Common minor cracks were observed in the foundation walls of the house. This implies that some structural movement of the building has occurred, as is typical of most houses.

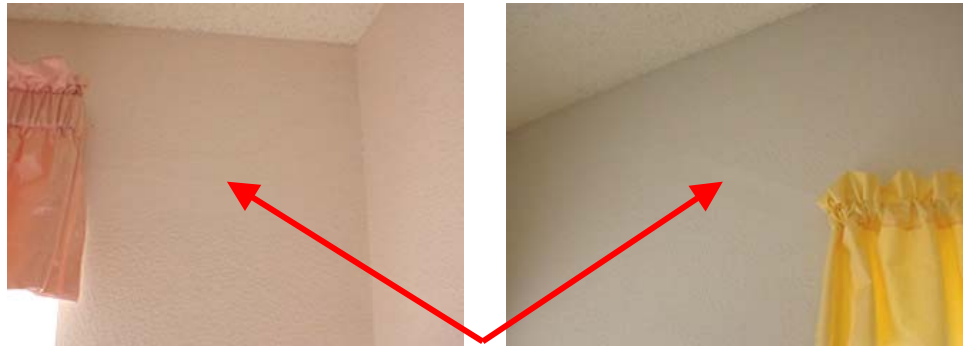
Patching was observed in various areas next to windows and doors where sheetrock cracks were located on the interior walls of the house. This implies that some structural movement of the building has occurred, as is typical of most houses.

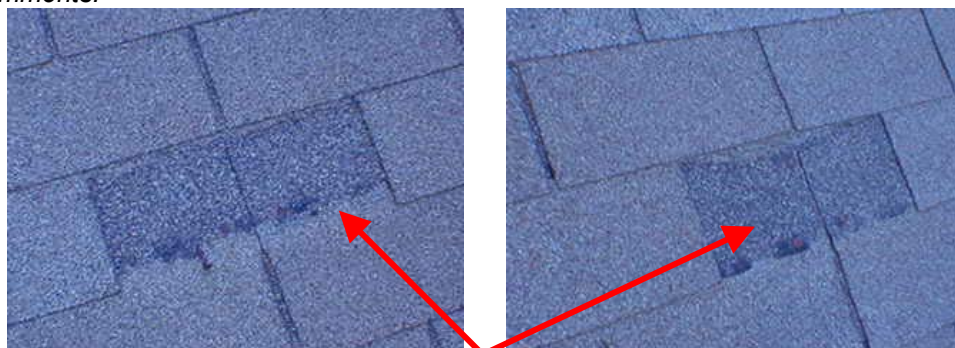
Minor repairs to the roofing are recommended. Damaged or missing roofing material should be repaired. All roof penetrations should be examined and sealed as necessary.

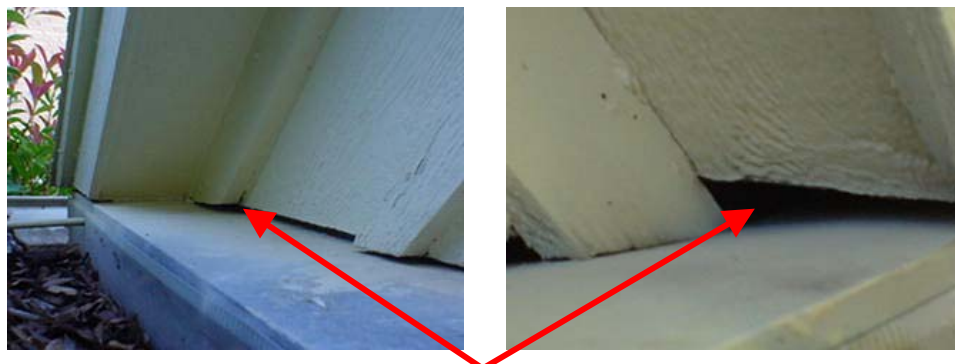
Note these areas are located in front of the garage, they are suspected to be channeling water into the garage walls causing water stains and eventual water damage. The scope of the visual home inspection can not reveal any extensive water damage that is located within the walls.

Note loose flashing, should be re-secured and all exposed nails should be sealed.

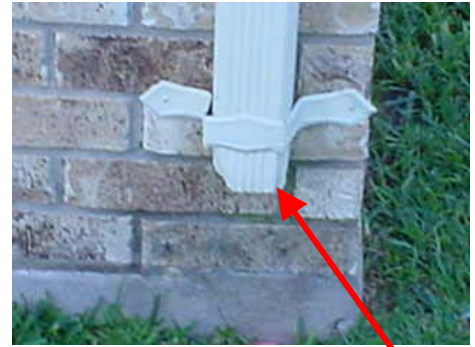
The downspout(s) should discharge water at least five (5) feet from the house. Storm water should be encouraged to flow away from the building at the point of discharge.

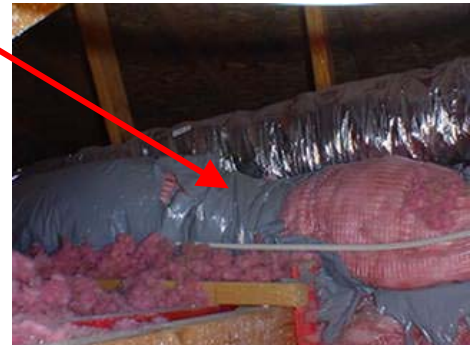
Ideally, the attic access hatch should be better insulated.

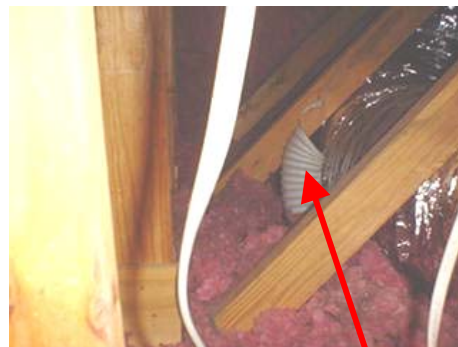
Exhaust vent pipes in the main attic should be insulated and vented to the building exterior.

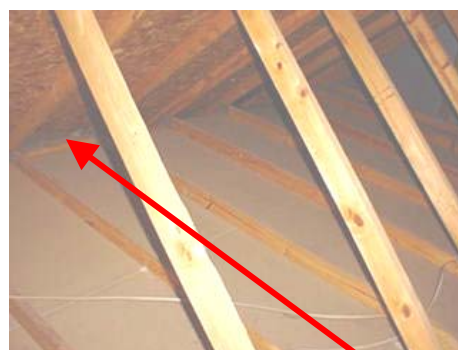
Note observed the decking with signs of water damage to a small area located near the front entrance.

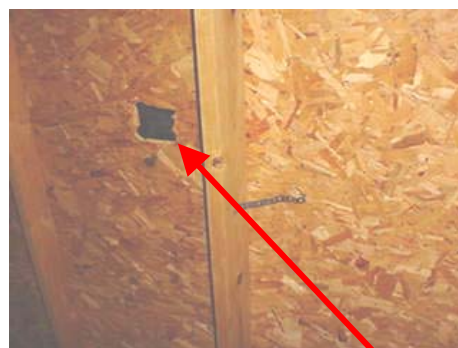
Note hole in decking, under-layment is torn as well. This should be repaired to help prevent failure of the roofing material.

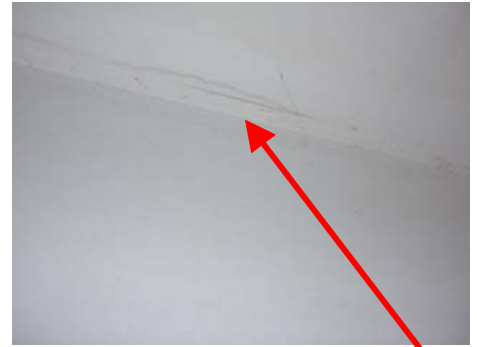
Water staining was noted in the garage. The cause for the staining should be determined and repairs undertaken, if necessary, to prevent structural damage.

Possible cause identified refer to exterior wall section.

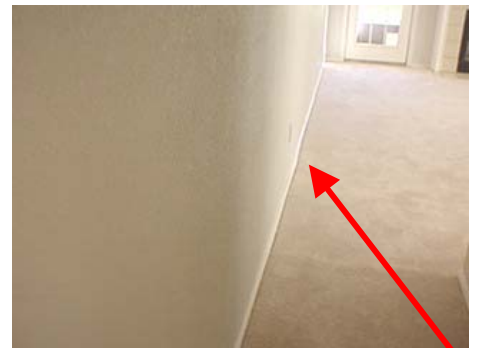
The interior wall shows signs of deflection.

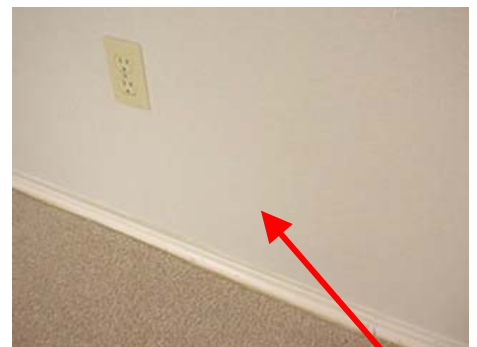
Although hard to see in the photograph, there is evidence of patching along the bottom of this wall where directly opposite this wall is plumbing fixtures that show signs of damage. (See Plumbing Section)

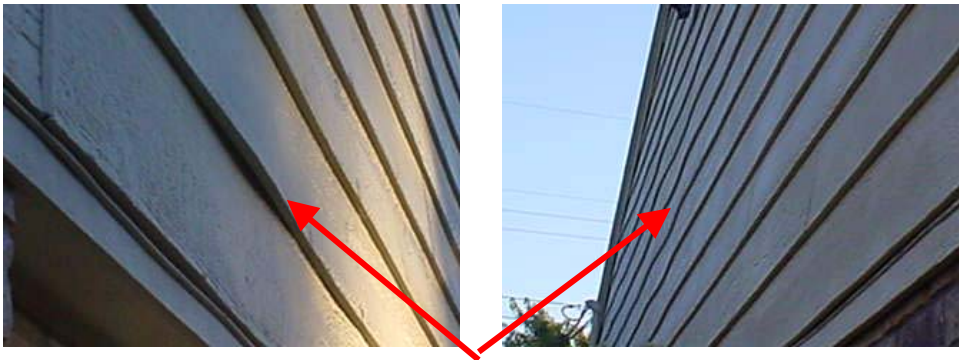
Siding shows signs of deflection (Wavy) and bowing, repairs should be undertaken.

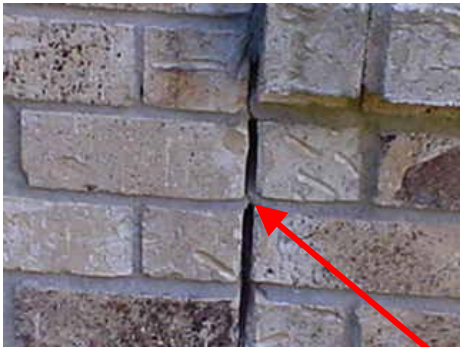
The expansion joint should be filled.

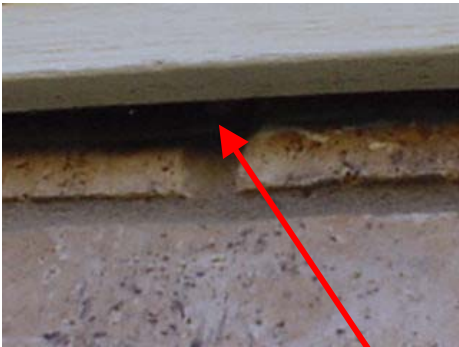
Openings where brick and siding meet should be sealed.

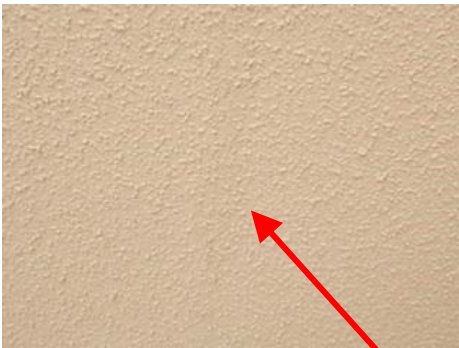
Water staining was noted in the west bedroom. The cause for the staining should be determined and repairs undertaken, if necessary, to prevent structural damage.

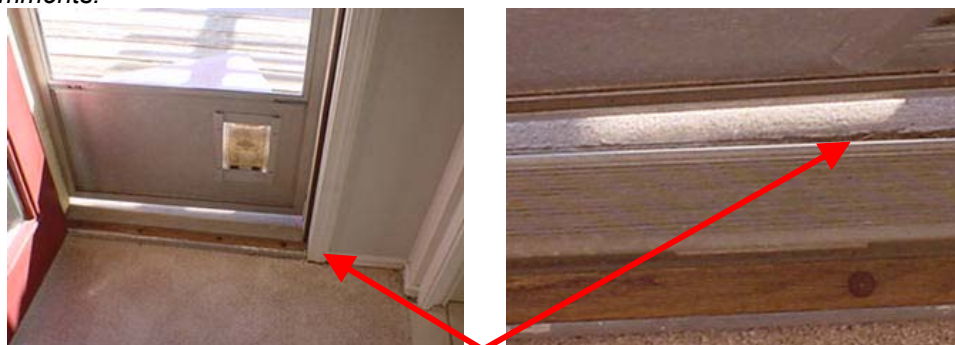
Water damage was observed adjacent to the door at the rear of the house. The cause should be determined and repaired to ensure proper operation of the door.

It is suspected that the water intrusion is coming from the bottom of the door, note that the threshold is not sealed properly therefore allowing water to enter underneath and wicking through the wooden trim boards.

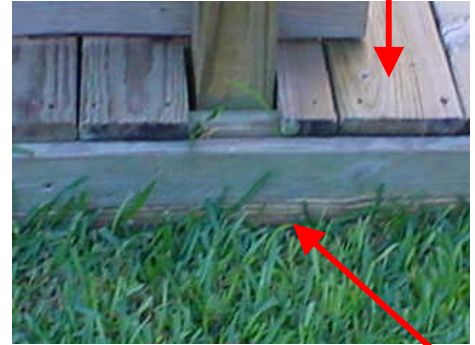
The deck at the rear of the house has been built at grade level. Repairs should be undertaken as this configuration is prone to rot and insect activity.

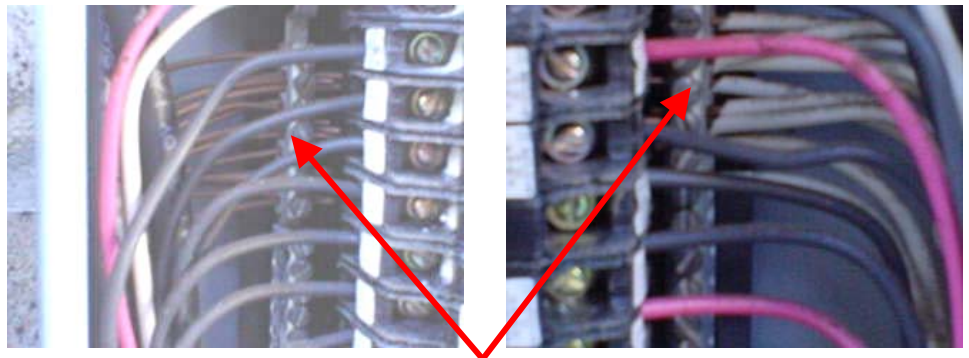
Note the ground and neutral wires are bunched together under just a few lugs. It is recommended that the full bus bar be used to its capacity before doubling these wires.

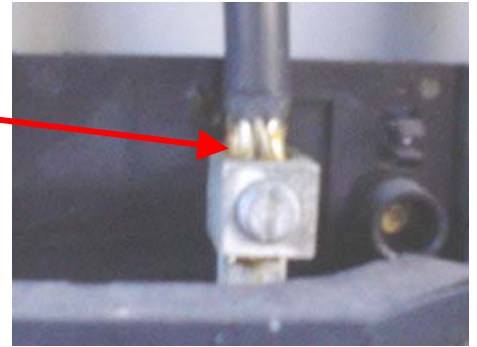
It is recommended that a qualified electrician verify that the proper torque is in use and that an adequate amount of antioxidant is applied to the aluminum wire termination.

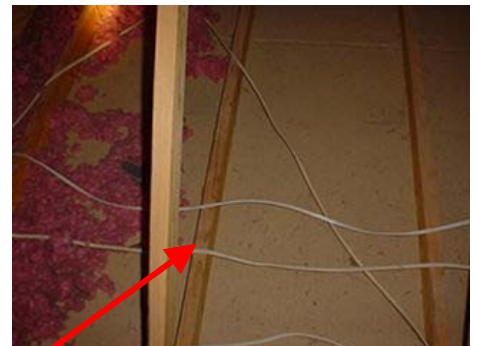
Loose wiring in the attic should be secured.

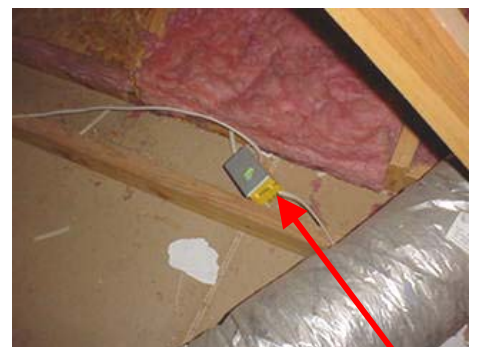
It is recommended that all junction boxes be properly secured.

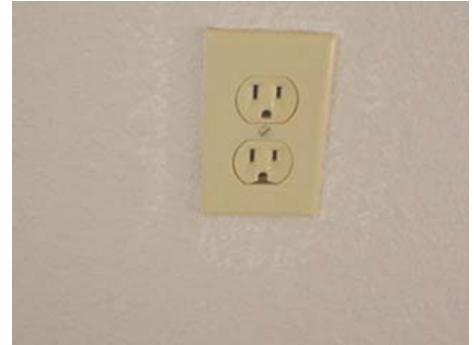
An outlet in the dining room is damaged. It should be replaced.

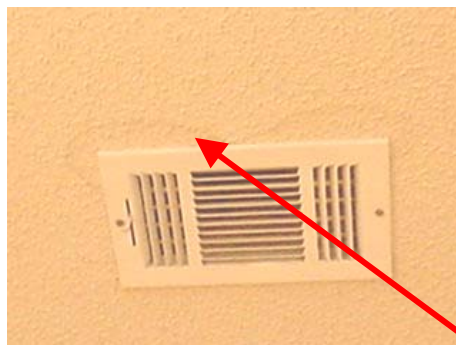
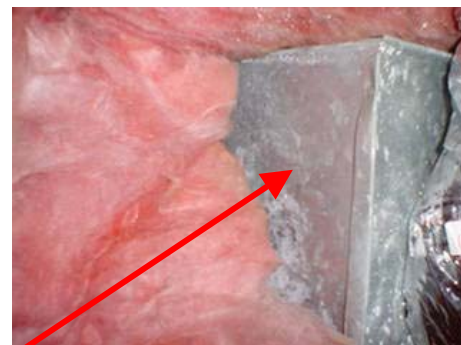
The supply air boxes should be better insulated to prevent condensation buildup causing water stains on the sheetrock ceiling.

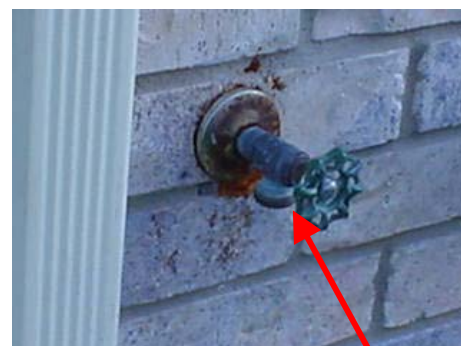
It is recommended that an anti-siphon device be added to the hose bib(s).

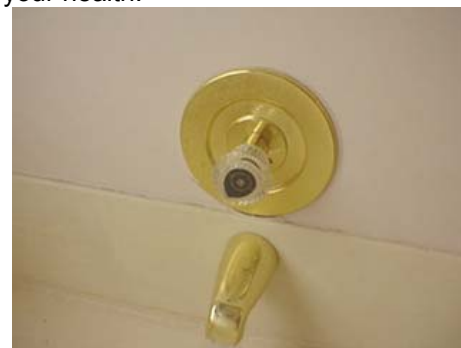
The hot and cold faucets in the master bathroom are reversed and should be repaired.

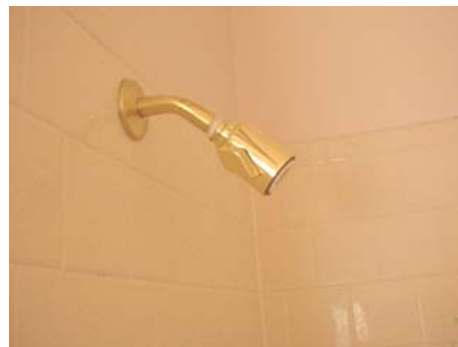
The showerhead in the master bathroom is in poor condition. Replacement may become necessary.

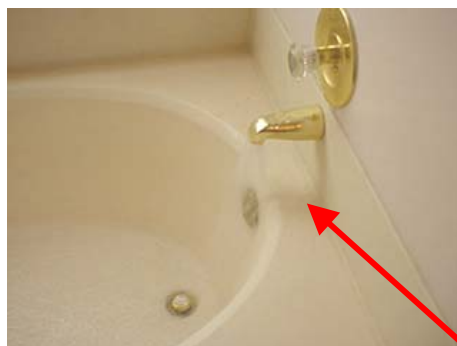
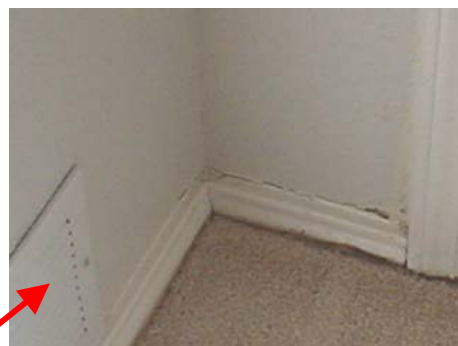
Note it is recommended that the faucet for the master tub be replaced with a longer fixture to prevent splash back. Also it is evident that the tub has been re-caulked. Note that directly opposite this wall in the family room there is a vent that has been installed.

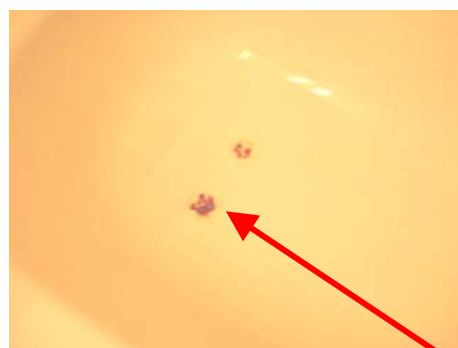
Note that the main bathroom's tub is damaged, cracked and rusted. This should be repaired to prevent further damage to the structure. Note that directly opposite this wall is the family room where the wall shows signs of deflection and a prior repair to the sheetrock. (See Interior Walls and Picture pages)

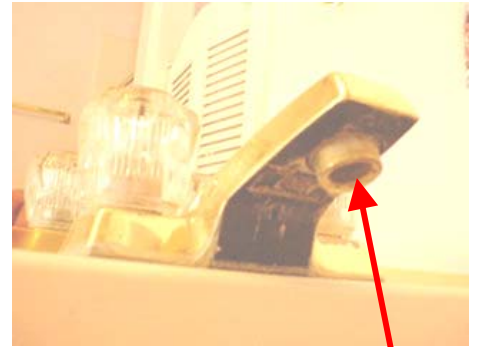
Note that the faucets are missing the screens to help provide a uniform flow

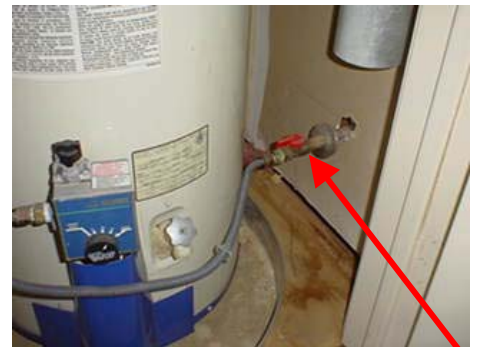
It is recommended that a sediment trap be installed on the gas line for the water heater.

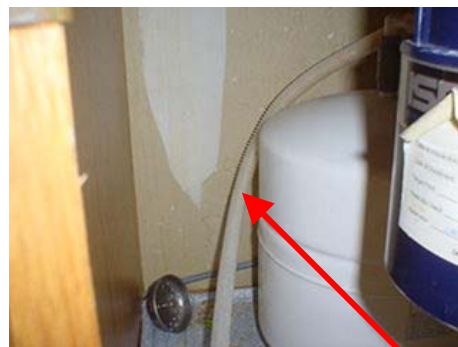
The dishwasher drain connection at the waste piping is considered marginal. This should be investigated and repairs undertaken, if necessary.

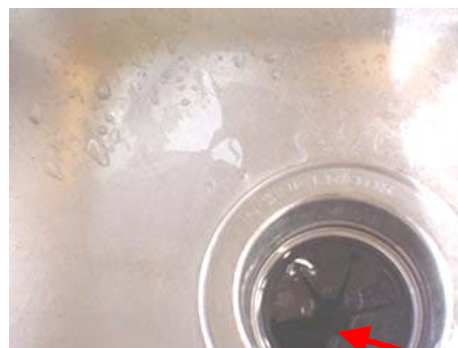
The splashguard for the food waste disposer is damaged and in need of repair.

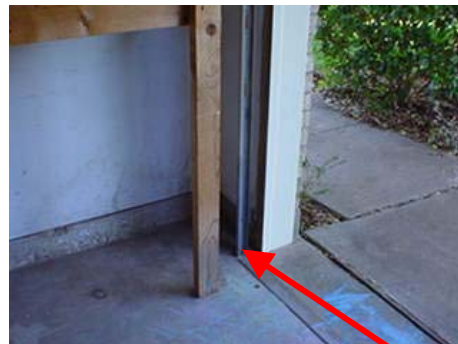
For safety reasons it is recommended that the addition of auto sensor device be installed for the garage door.

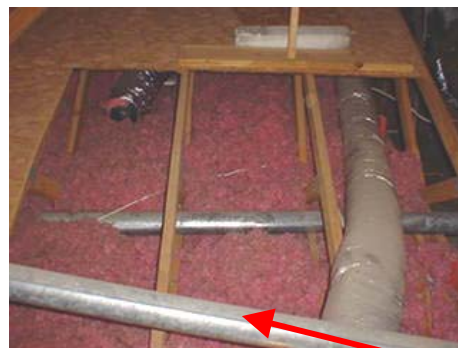
Comments: It is suspected that the dryer vent is too long. This should be further evaluated and or repaired.
