Beneficial Home Inspections

Your Home Inspection Report

Address - 1111 Sample Drive
Inspection TX

PROPERTY INSPECTION REPORT

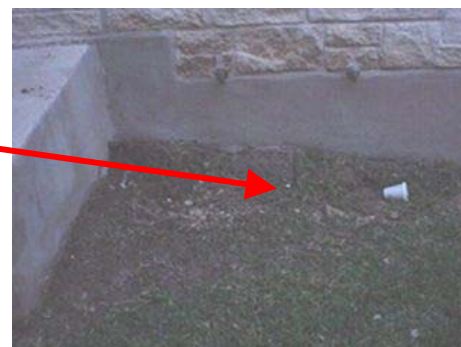
I recommend that additional guttering be installed on both sides of the house. This will help prevent the erosion of soil that is adjacent to the foundation. As you can see minor erosion has already taken place.

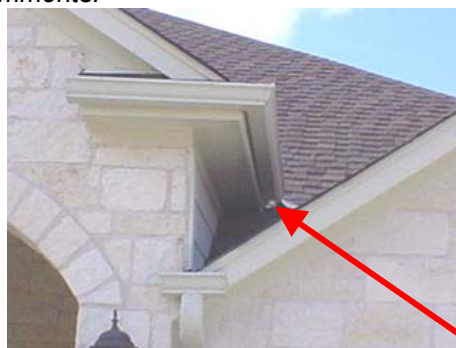
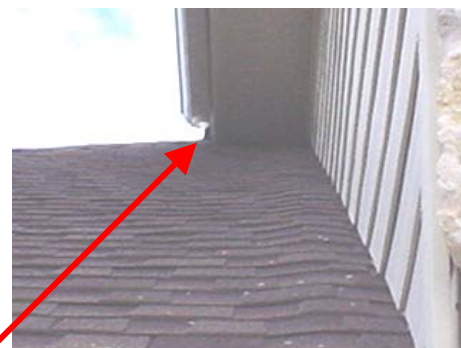
Downspout(s) that discharge onto the roof should be extended to discharge directly into the gutters below. This condition, if left unattended, can result in premature deterioration of the roofing under the end of the downspout. This is apparent in the front of the house next to garage as well as in two places on the back slope.

The downspout(s) should discharge water at least five (5) feet from the house. Storm water should be encouraged to flow away from the building at the point of discharge.

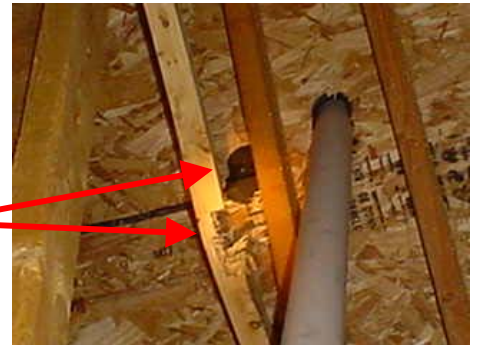
Note - where the Collar Tie has been severely knotted out causing failure to the structural support, this should be repaired. As you can see a hole was drilled into the decking, which was not used. Note the felt underlayment visible. This should be repaired.

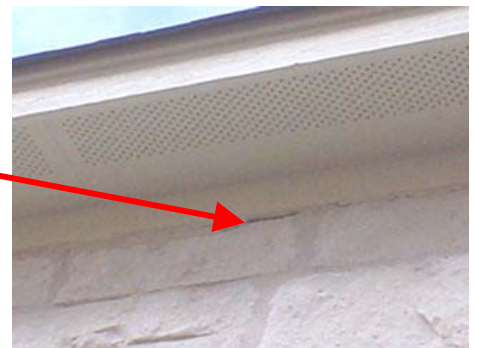
Typical minor cracking, loose mortar at the junction of the rock wall and the trim was observed on the exterior walls of the house. This should be repaired and monitored on a consistent basis.

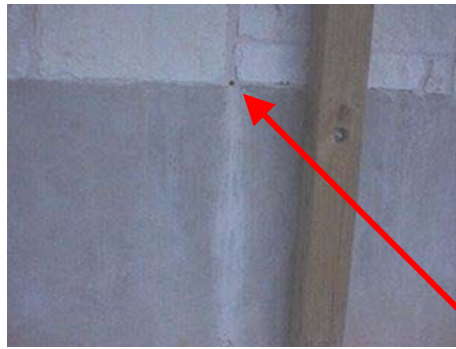
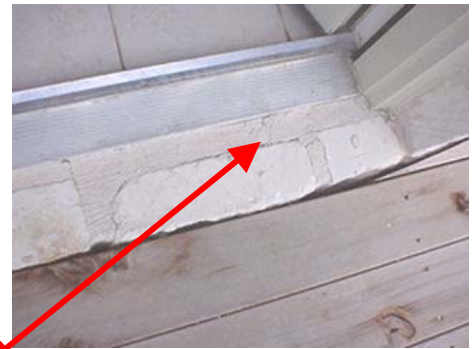
Note at the back of the house under the deck where evidence of excessive moisture is draining from the weep holes, this implies that excessive water is intruding into the wall cavity. The suspected area of water intrusion is the windowsills and doorsills directly above this area where there is moderate cracking and loose mortar. This should be repaired and monitored on a consistent basis.

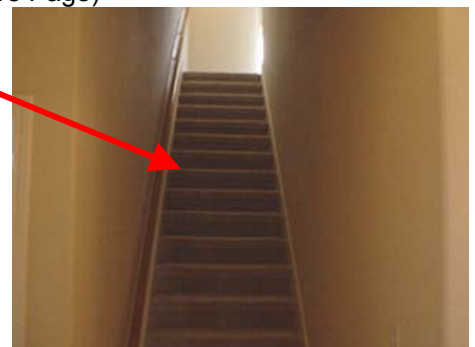
Minor cracks in the ceiling were noted. This condition is mainly cosmetic in nature and should be patched. (See Picture Page)

For safety reasons additional lighting may be desirable for the stairway.

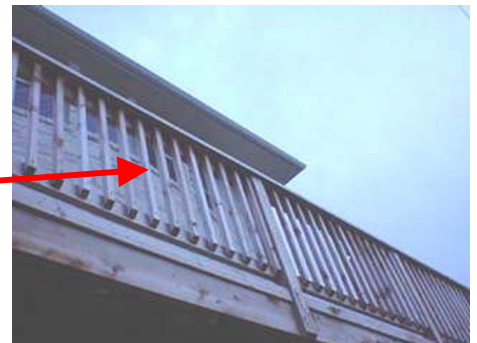
The deck railing at the rear of the house is loose. It is recommended that this be repaired for improved safety.

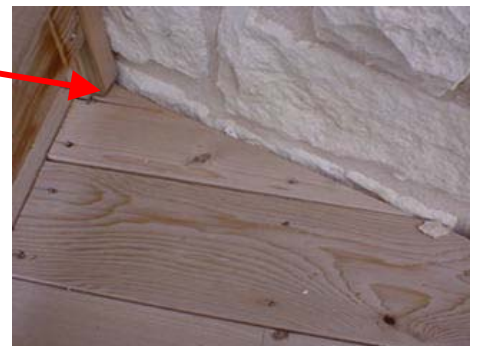
Note – the last decking board is not well supported this should be repaired.

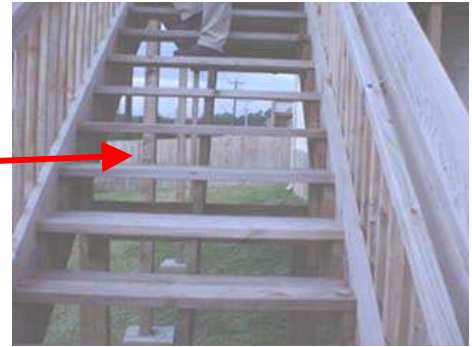
The openings on the stair risers are considered to be too large allowing a small child to be injured. The opening should not allow a 4" sphere to pass through. This should be repaired for improved safety.

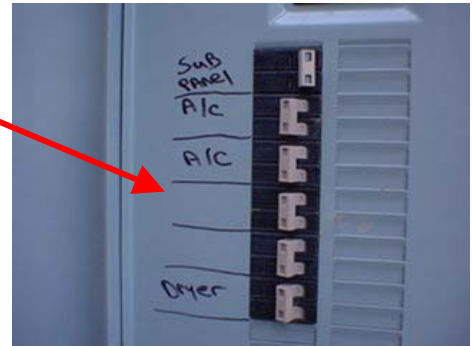
All breakers should be marked as to what circuit they protect.

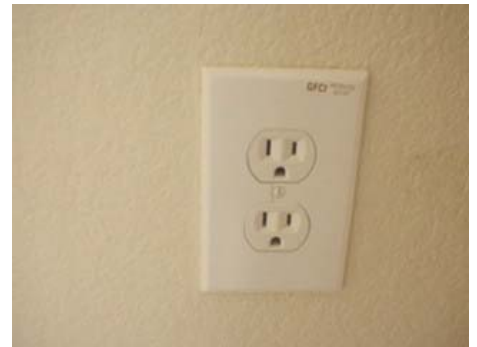
A ground fault circuit interrupter (GFCI) outlet in the garage did not respond correctly to testing during the inspection. This receptacle should be repaired.

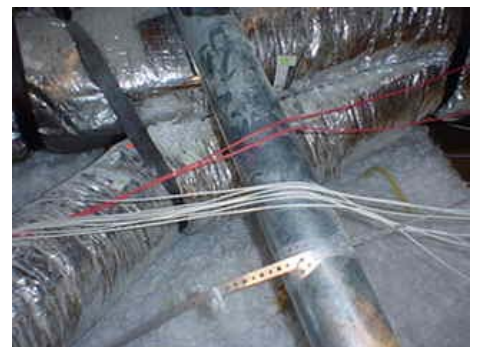
Wiring in the attic should not touch hot air ductwork or hot water piping. Note - The wiring is communication wiring.

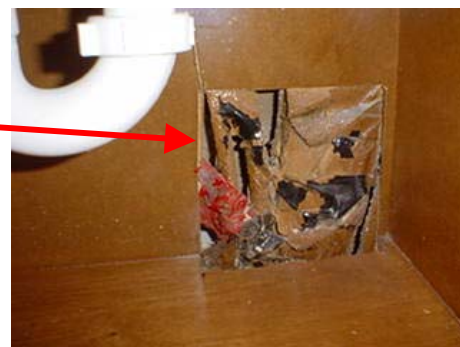
Note – where the plumbing pipes were not installed within the wall cavity area, causing modifications to be done to the bathroom vanity cabinet. This should be repaired.

Note – if this is not repaired properly, energy efficiency and the fire wall protection that the sheetrock provides could be compromised.

Note a correct repair would involve removing the cabinet and wall covering, readjusting the plumbing pipes and securing them within the wall cavity.

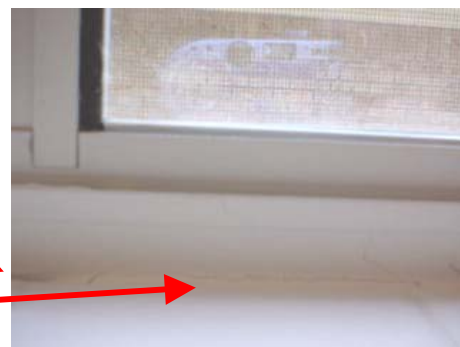
Cracked, deteriorated and/or missing bathtub enclosure grout and caulk should be replaced.

The window and sill of the bathtub enclosure should be protected from moisture. A waterproof curtain is usually sufficient. Windows in bathtub enclosures have a reputation for allowing leakage behind the enclosure, causing damage to the wall.

(Note cracking already taking place)

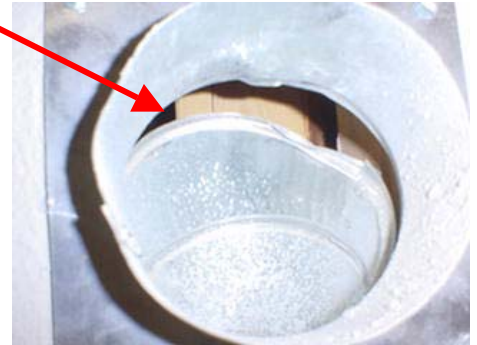
Note dryer vent piping is not secured; this should be repaired prior to use.

Note framing members and wall cavity exposed, if used without repair it can cause excessive moisture entering the wall cavity as well as excessive heat.

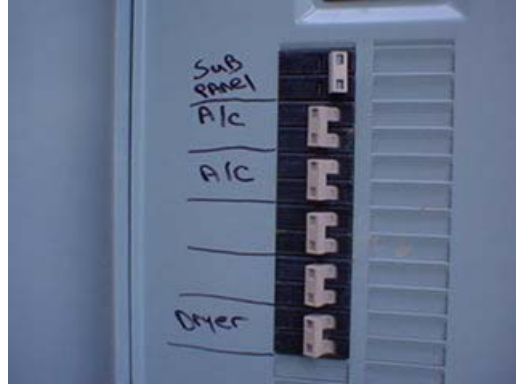
The over current protection for the small air conditioning unit is oversized and should be repaired. On the main panel it is marked that a 60-amp breaker is protecting a unit that is rated for a maximum 25-amp breaker.

All breakers should be properly identified. 60-amp breaker protecting outdoor AC unit rated for max. 25 Amps.

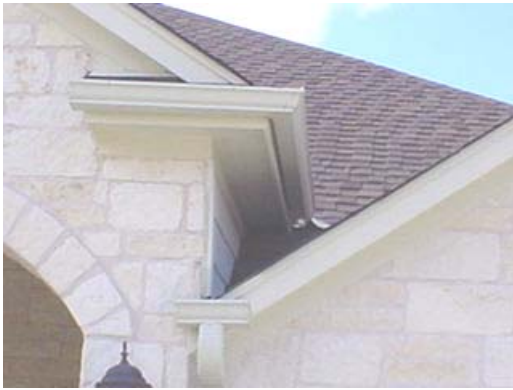
Down spout to shingles, This causes premature deterioration of the shingles.

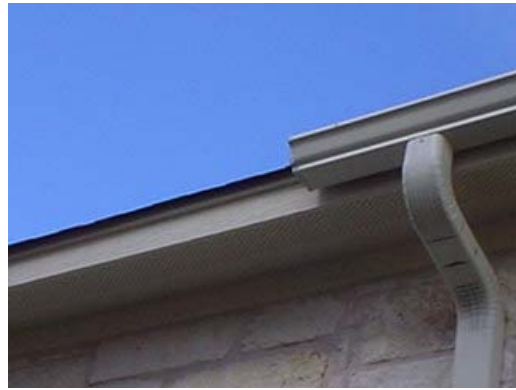
Recommend the extension of the gutters to include the entire side of the house or at least protecting the electrical service panel.

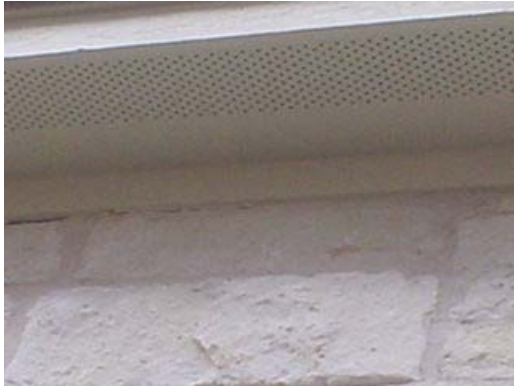
Cracking and loose mortar joints between the rock exterior and siding should be repaired.

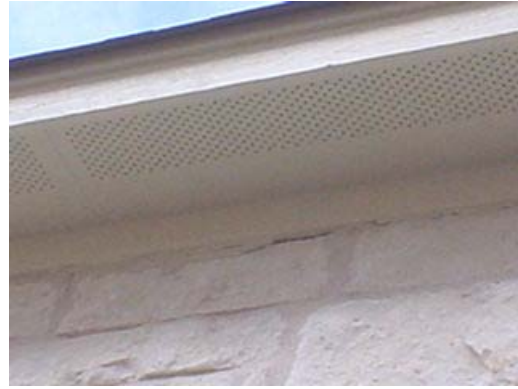
Cracking and loose mortar joints

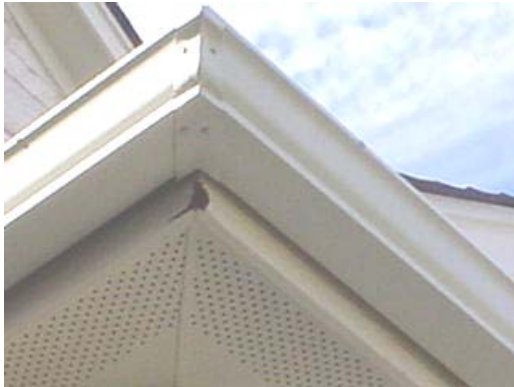
Damaged trim located in the front of the house should be repaired and protected with a coat of exterior paint.

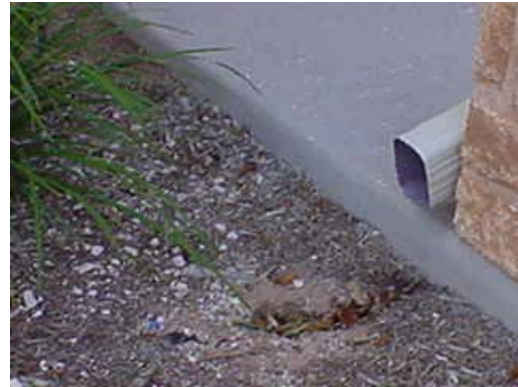
Recommend diverting the drain water from the downspout well away from the foundation

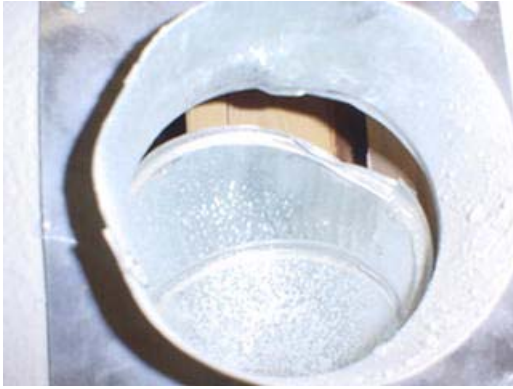
Note the dryer vent not secured, you can see the framing members and into the wall cavity.

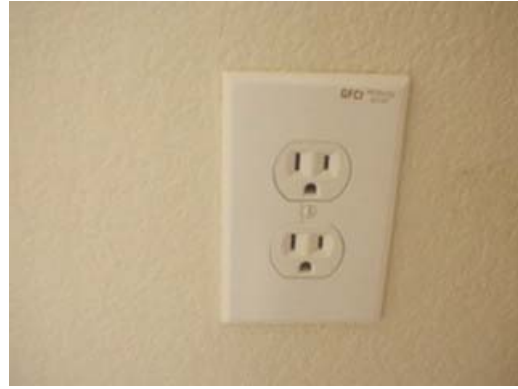
GFCI labeled receptacle in the garage did not respond favorable to the test and should be repaired.

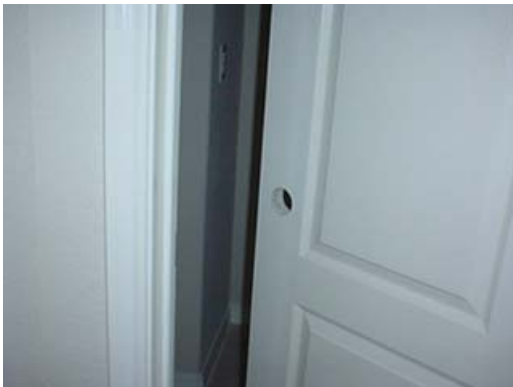
Missing Door Hardware for half bath.

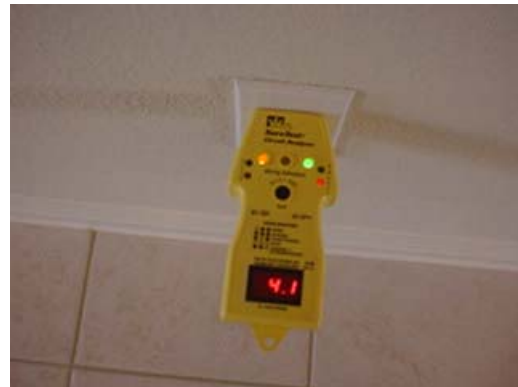
An outlet in the front entrance has reversed polarity (i.e. it is wired backwards). This outlet and the circuit should be investigated and improved as necessary.

Reversed Polarity receptacle located in the front entrance hallway.

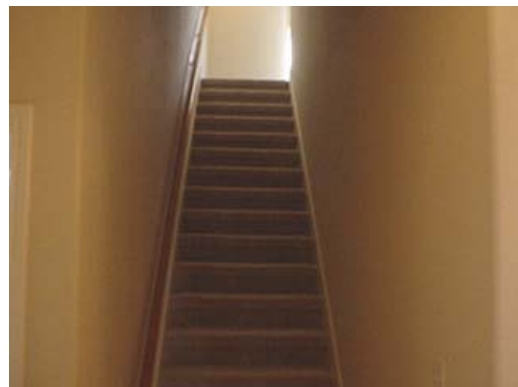
For Improved safety I recommend additional lighting for the stairway area.

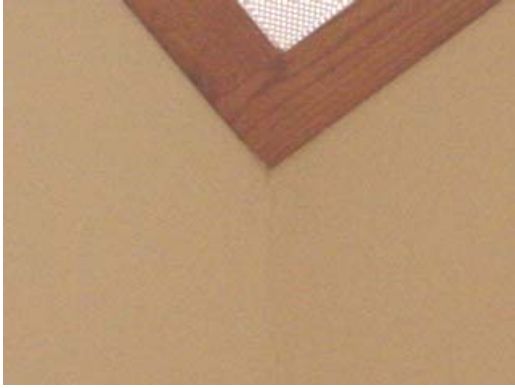
Sheetrock cracking in skylight area

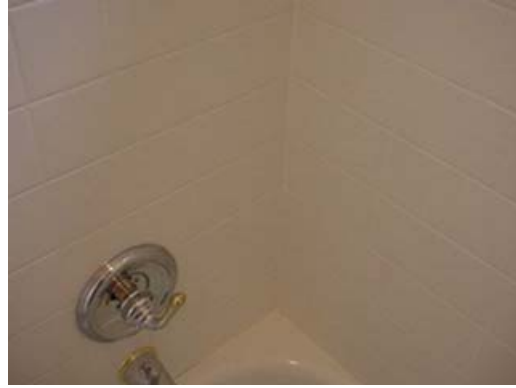
Re-caulk the bathtub tile enclosures.

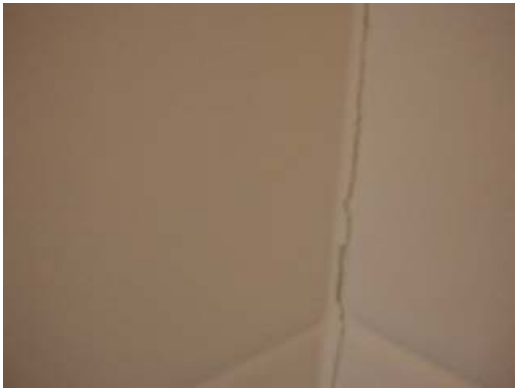
Cracking above the tile in bathtub enclosure.

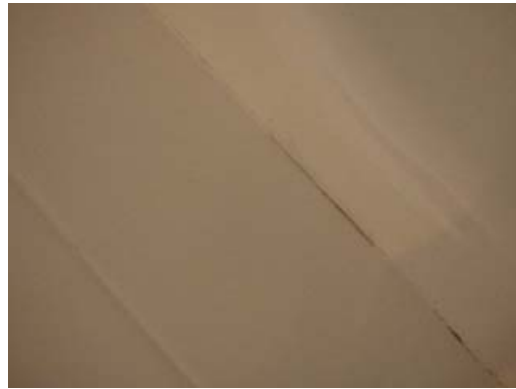
Caulk area between tub and tile

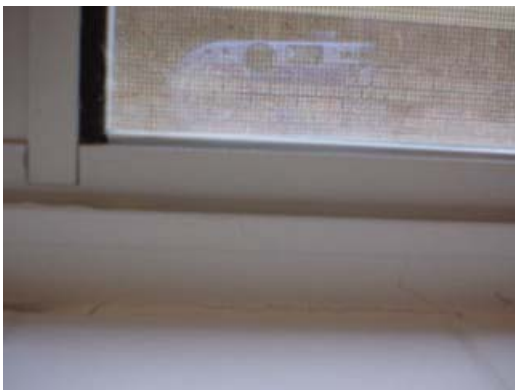
Window seal vulnerable to moisture intrusion monitor this area on a consistent basis and repair as needed.

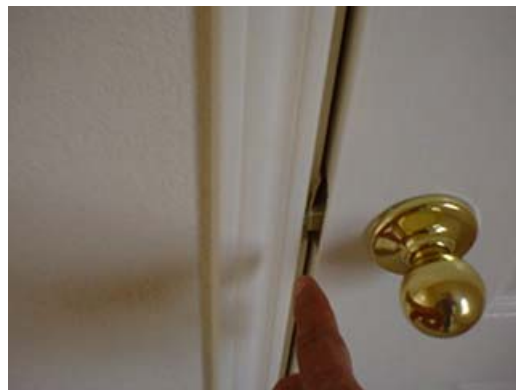
The back bathroom door does not close and latch properly, a minor adjustment to the strike plate may be all that is needed.

Door does not latch properly; minor adjustment to strike plate may be all that is needed.

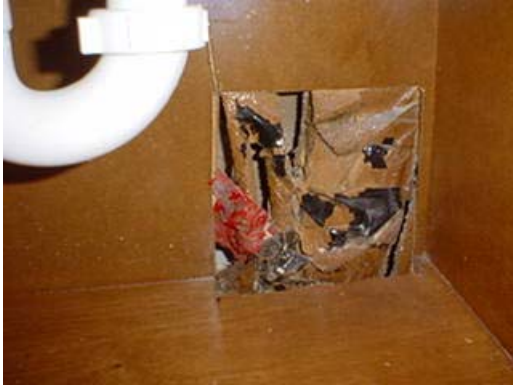
Poor workmanship on the plumbing pipe installation. It appears modifications were done to the bathroom vanity cabinet because pipes were not installed within the wall cavity.

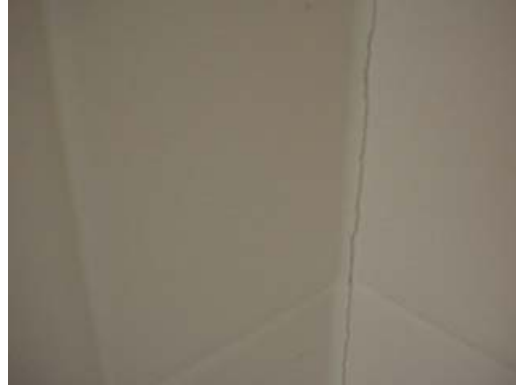
More cracking observed in the bathtub enclosures, this should be repaired prior to use.

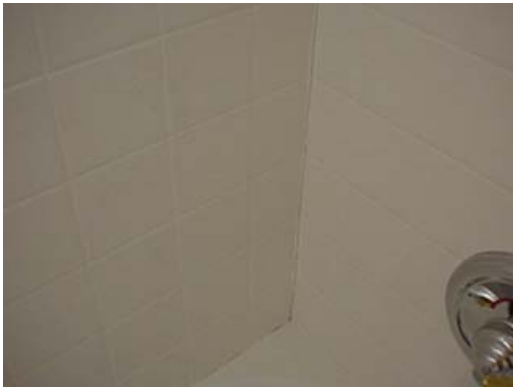
Caulk this area

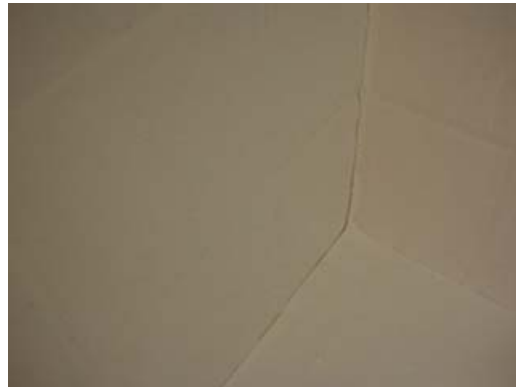
Caulk this area

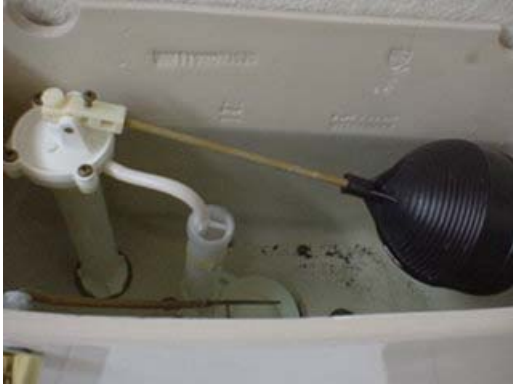
Minor adjustment needed to back bathroom toilets valve. Toilet runs on, this should be repaired.

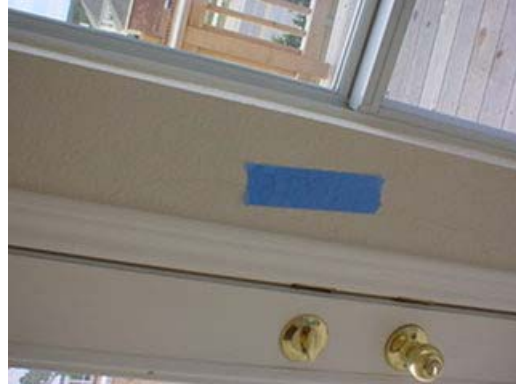
Moderate cracking of sheetrock due to expansion and contraction and /or settlement of framing members. This should be repaired.

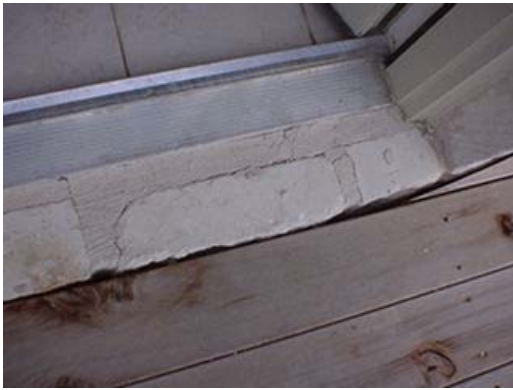
Cracking and loose mortar at the doorsill should be repaired.

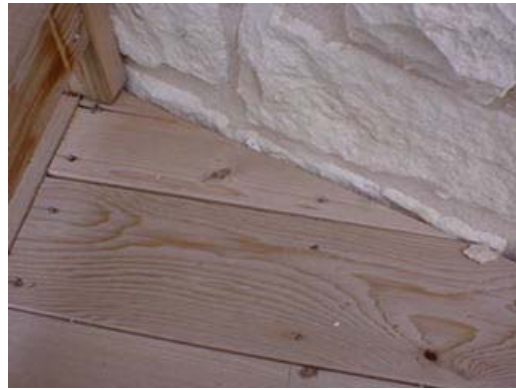
Back decking board is not secured properly this should be repaired.

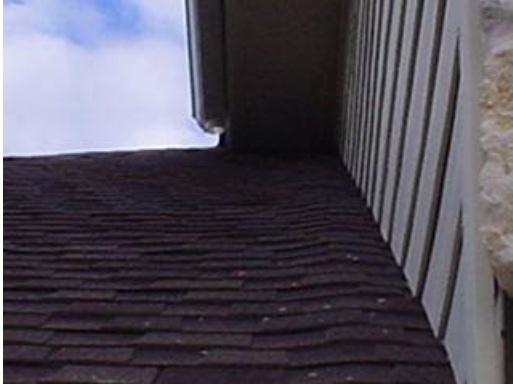
Gutters draining right on top of shingles can cause premature failure of shingles in this area.

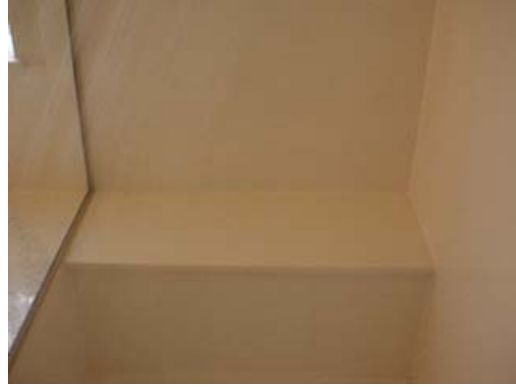
The sitting area located in the master bath shower stall should be monitored on a consistent basis for failure of sealant. At this time it appears to be in good shape but these areas are vulnerable to moisture intrusions.

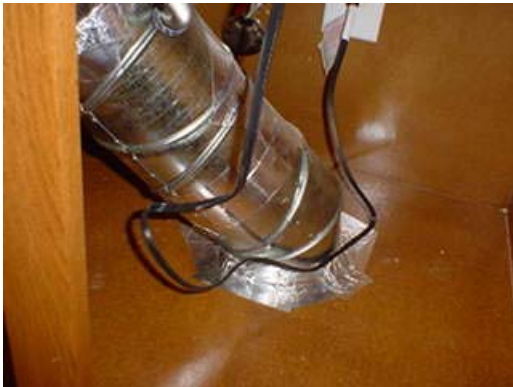
Electrical wiring in contact with flue vent, located under cabinet in kitchen.

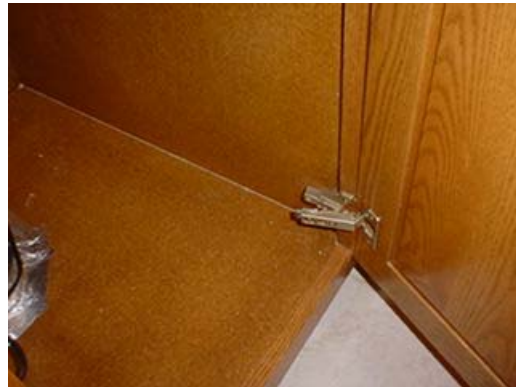
Cabinet door hinge needs repair

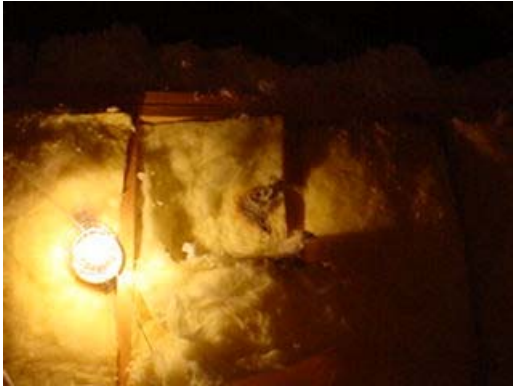
Incandescent light considered to be too close to combustible materials and should be repaired.

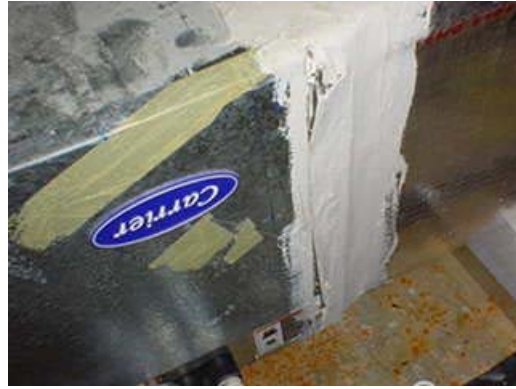
Seal has been cut on the HVAC unit - this should be repaired.

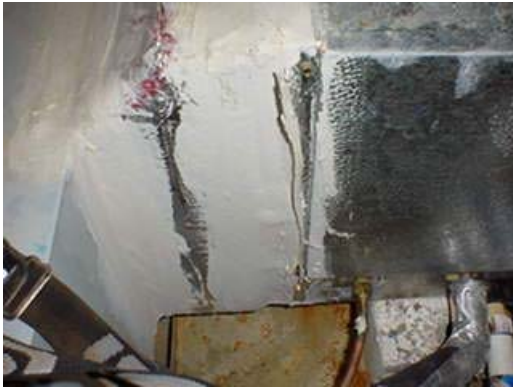
Seal cut here, should be repaired.

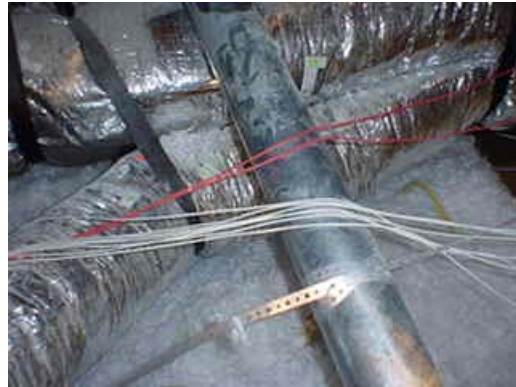
Communication wiring touching heater flue vent, wiring should be rerouted as to not being in contact with heater flue vent.

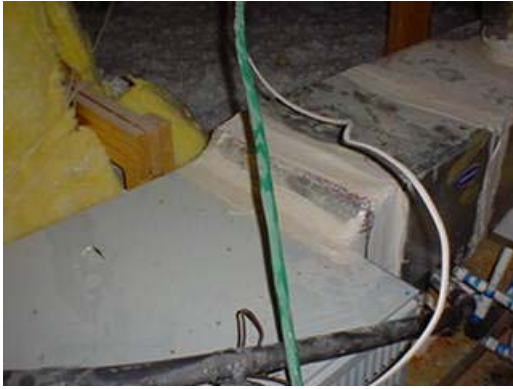
Loose wiring should be better secured and protected.

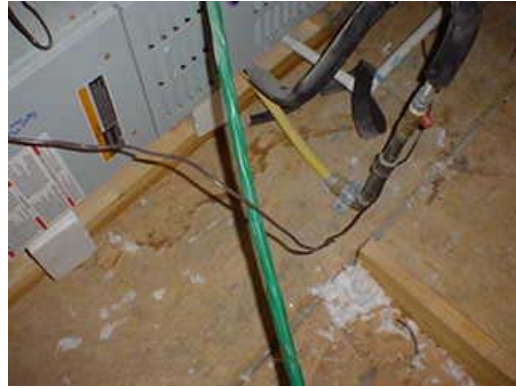
Data cable lines should be secured to allow better access to HVAC system.

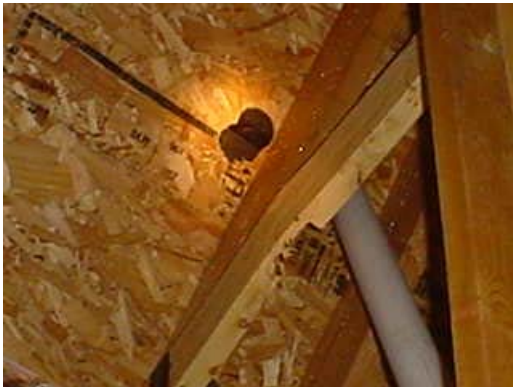
Note - Collar tie severely notched causing failure of the framing member, should be repaired. Also hole in roof decking should be repaired.

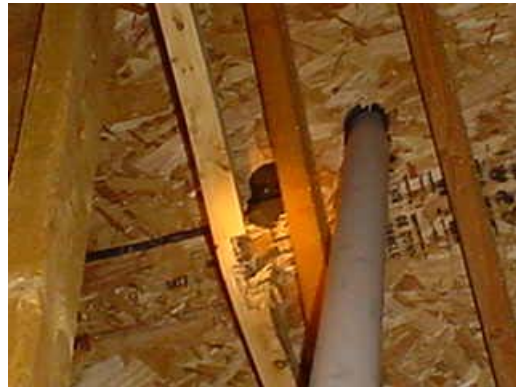
Hole in roof decking and collar tie severely notched causing damage, this should be repaired.

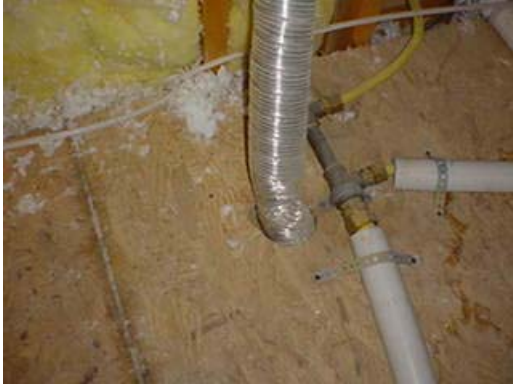
Flexible exhaust piping is damaged and should be repaired.

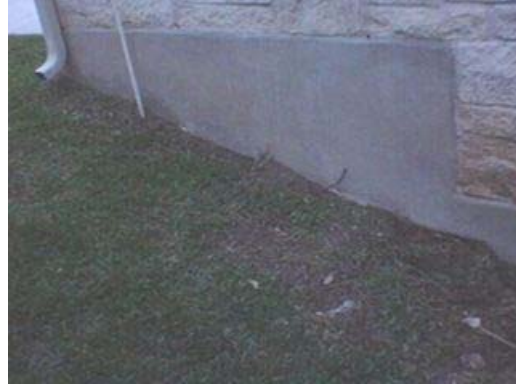
Evidence of erosion, recommend guttering be extended on both sides of the house.

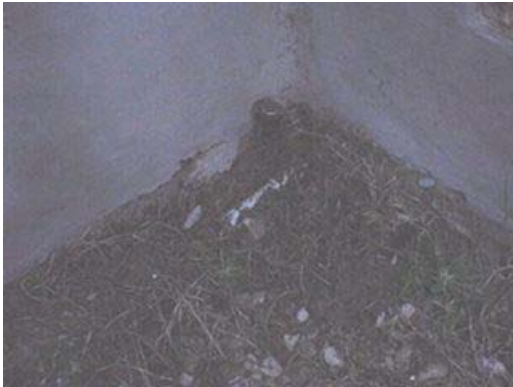
Erosion and exposed sprinkler system piping. Piping for sprinkler system should be at a minimum depth of 6".

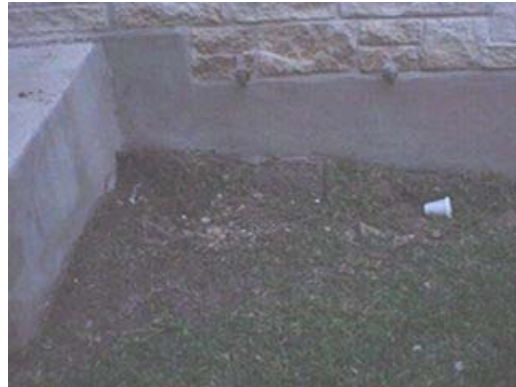
Erosion already taken place.

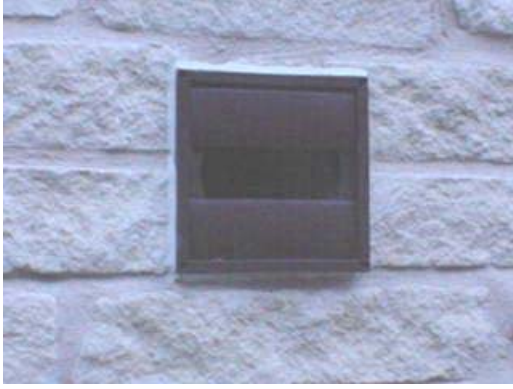
Vent cover missing back draft panel, should be repaired.

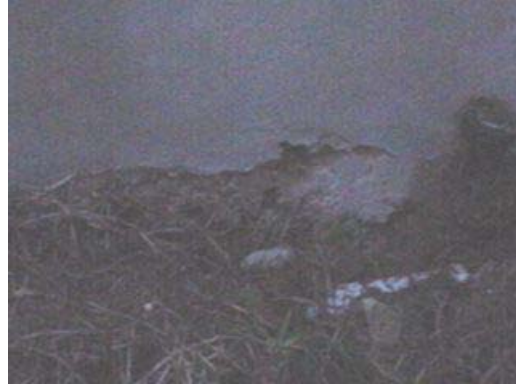
Erosion and sprinkler system pipe exposed, needs repair.

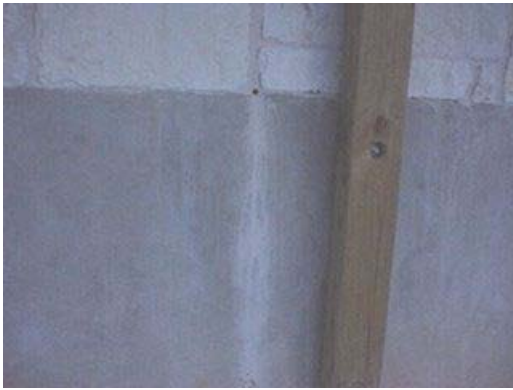
Evidence of excessive moisture flowing out of weep holes.

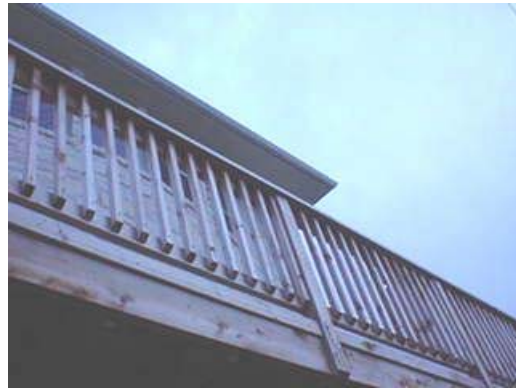
Railing considered loose, should be repaired for safety.

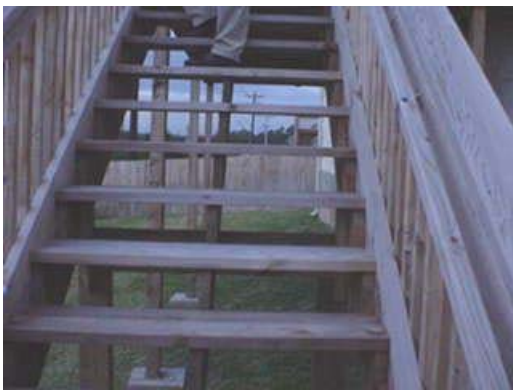
Stair riser openings are considered too large; this should be repaired for improved safety.

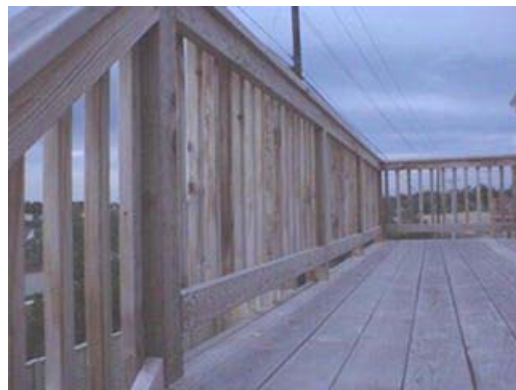
Railing loose.

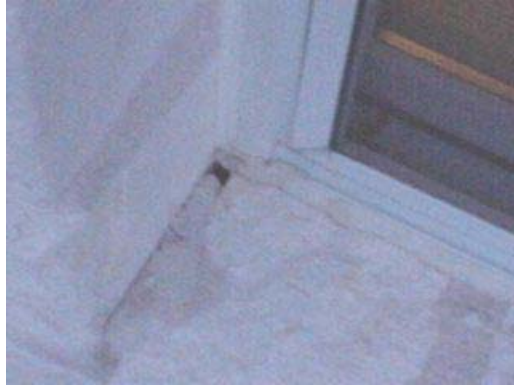
Suspected area where excessive moisture intrusion occurs, this should be repaired.
