Beneficial Home Inspections

Your Home Inspection Report

Address - 1111 Sample Drive
Inspection TX

PROPERTY INSPECTION REPORT

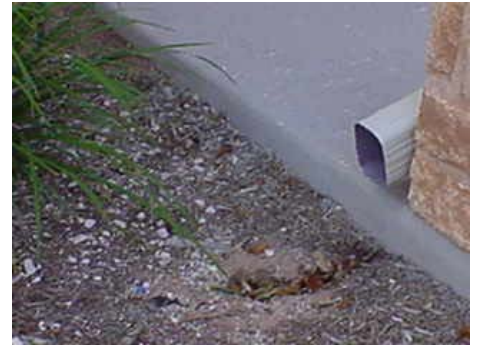
The downspout(s) should discharge water at least five (5) feet from the house. Storm water should be encouraged to flow away from the building at the point of discharge.

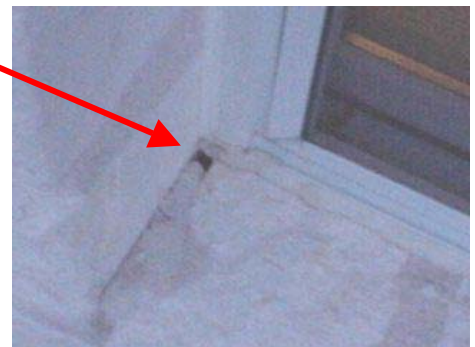
Note at the back of the house under the deck where evidence of excessive moisture is draining from the weep holes, this implies that excessive water is intruding into the wall cavity. The suspected area of water intrusion is the windowsills and doorsills directly above this area where there is moderate cracking and loose mortar. This should be repaired and monitored on a consistent basis.

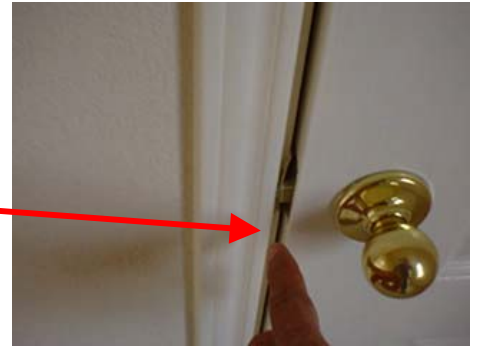
The back bathroom door does not close and latch properly, a minor adjustment to the strike plate may be all that is needed.

Doors should be trimmed or adjusted as necessary to work properly.

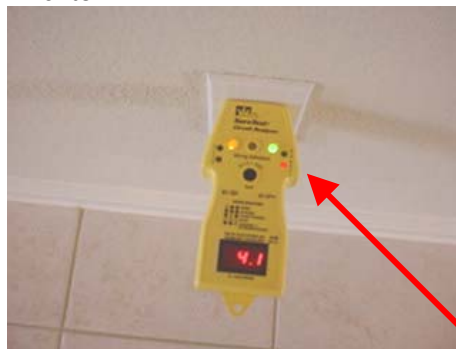
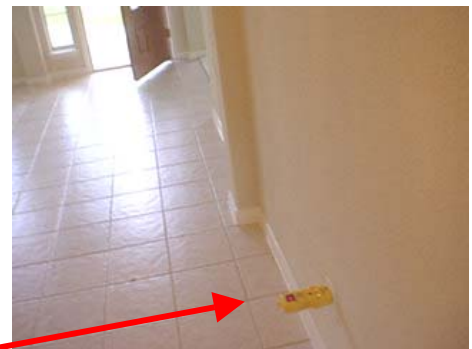
An outlet in the front entrance has reversed polarity (i.e. it is wired backwards). This outlet and the circuit should be investigated and improved as necessary.
